DMK Home Inspections LLC

INSPECTION OF
17-23 STREET AVENUE
ROCHESTER NY
FOR
TIM CLIENT

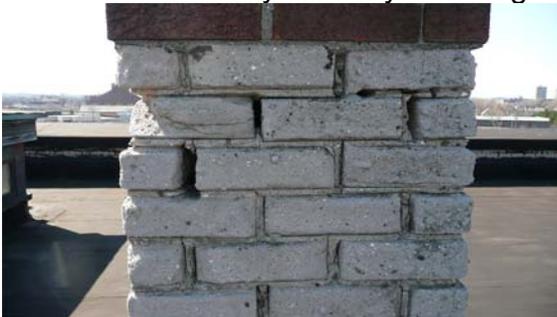
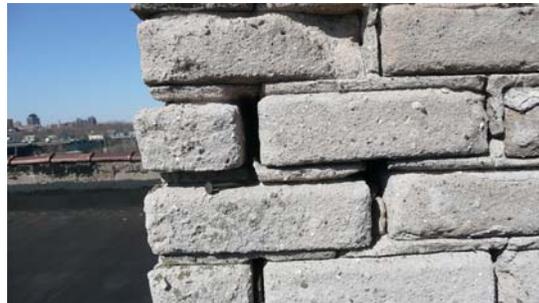
- a. The upper roof was modified bitumen.
- b. The masonry chimney servicing the oil furnace needs to be repointed.

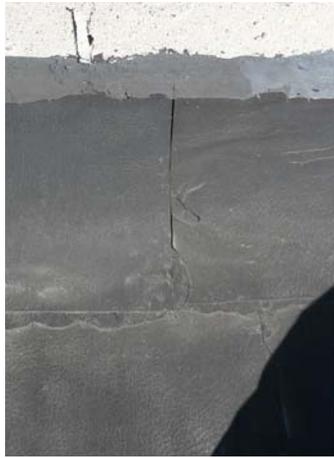
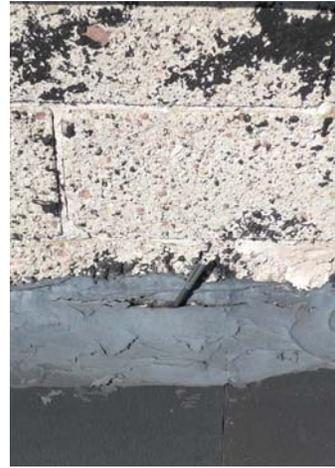
- c. The flashings @ the parapet wall, skylight wall & hoist way walls have detached in many locations allowing for water infiltration.

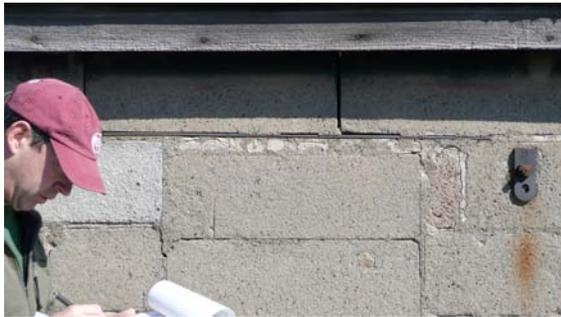
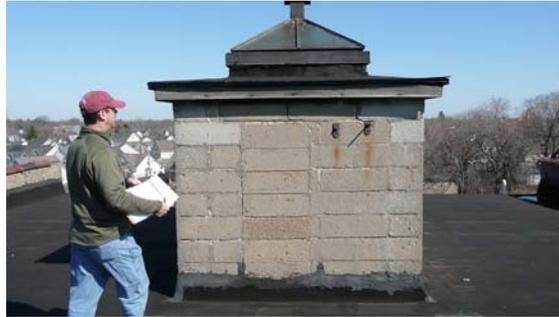
- d. The parapet and hoist way walls need to be repointed. The hoist way wall had several loose blocks. Unable to gain access to the hoist way via the roof door or the third floor door as it was locked and no key was available.

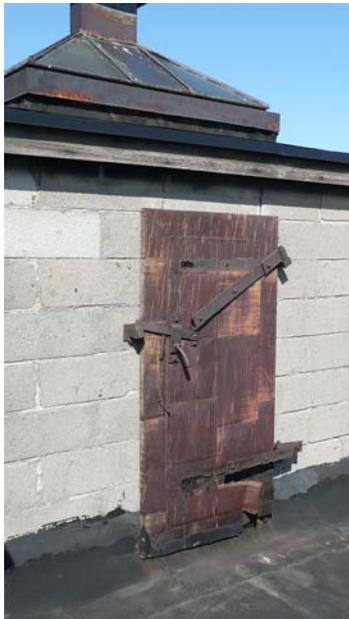
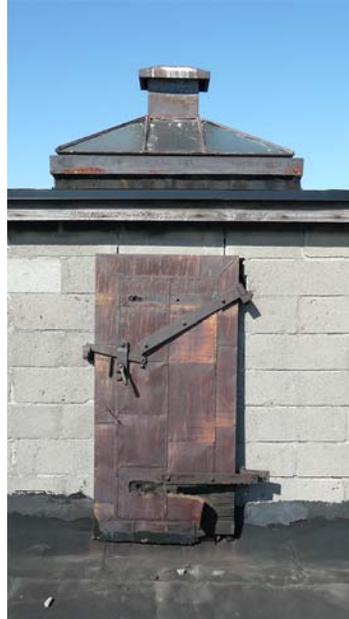
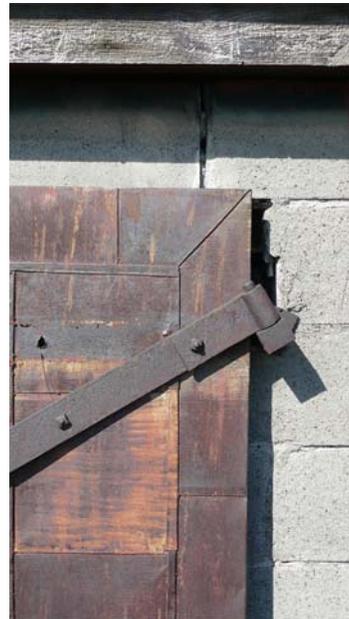
- e. The door to the hoist way from the roof is deteriorated and will need to be replaced. Hinges have been ripped off and due to its state, water and air infiltration is occurring.

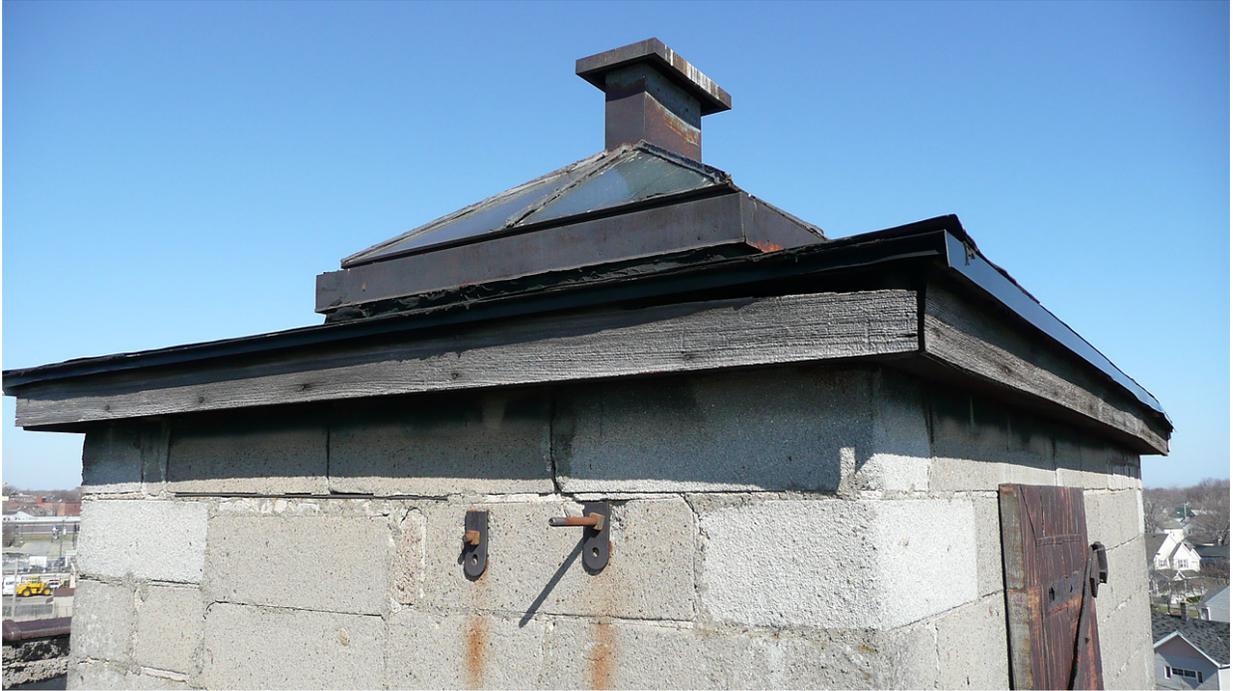
- f. Most of the wood at the hoist way and at the skylight above the hoist way is in need of repair or paint. Rot was evident in many locations.

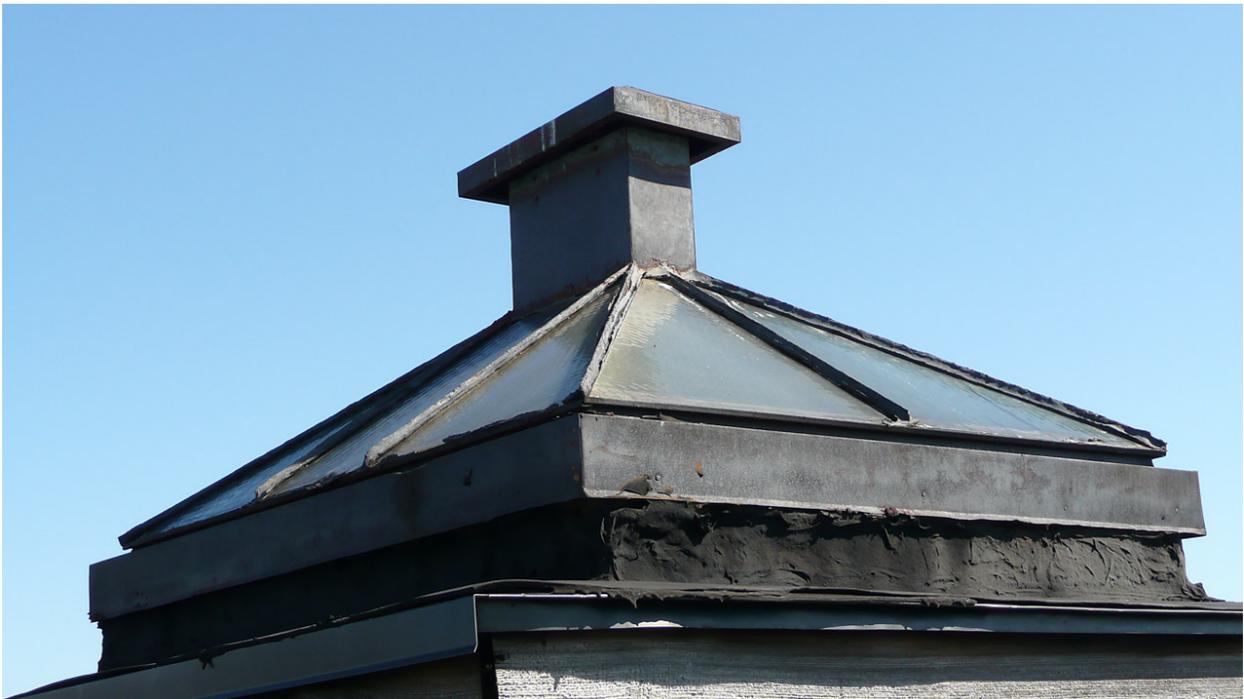
- g. The glazing/framing @ the hoist way skylight is deteriorated and will need to be repaired.

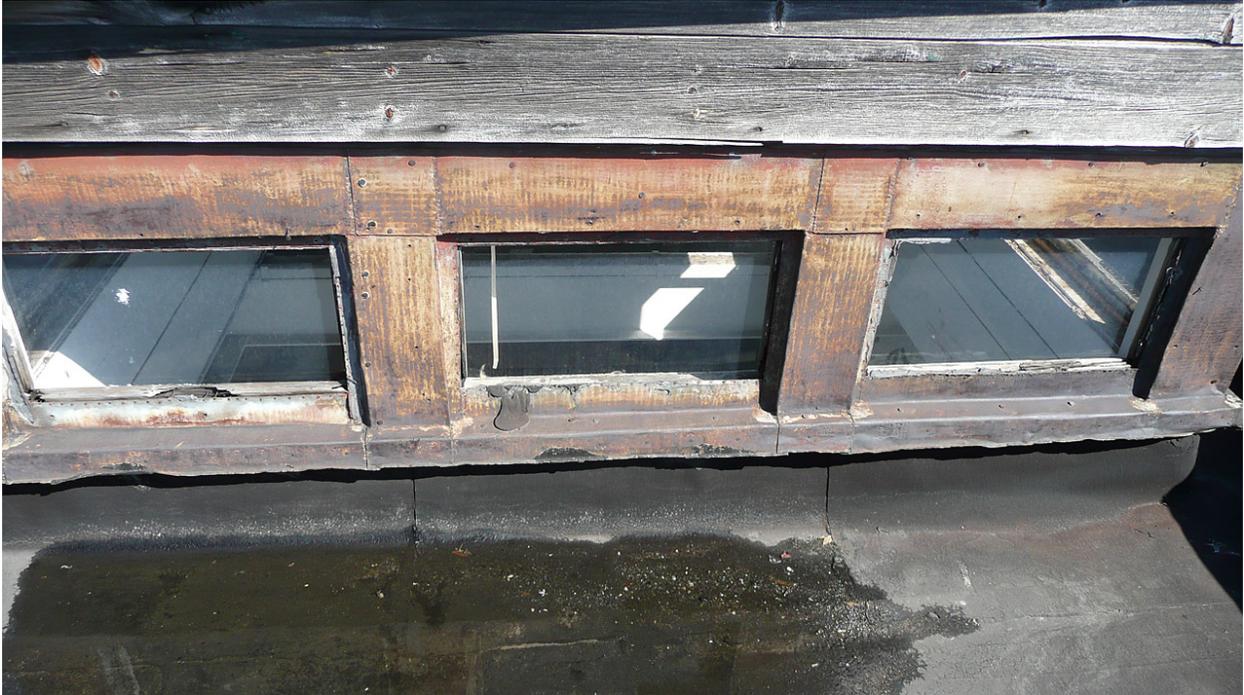
- j. Some moisture bubbles found under roof membrane. These can be corrected via the installation of a one way vent.
- k. Most of the exterior wood at the skylight and at the roof above the skylight is in need of repair or paint. Rot was evident in many locations. In general the skylight will need some reconstruction of the exterior envelope.

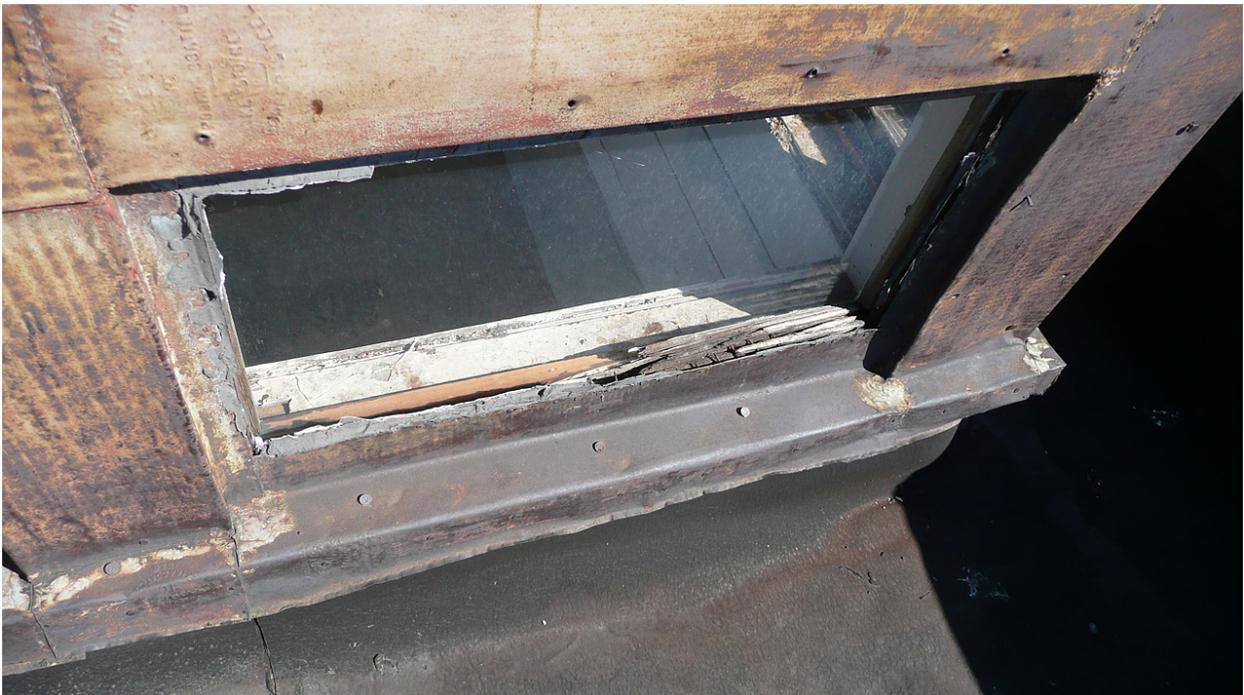
- l. The windows in the skylight are completely rotted in locations allowing for water infiltration to below the roof surface.

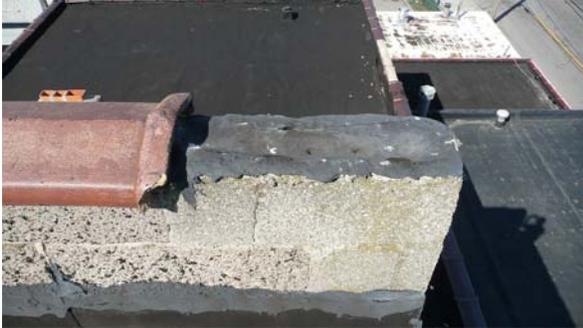
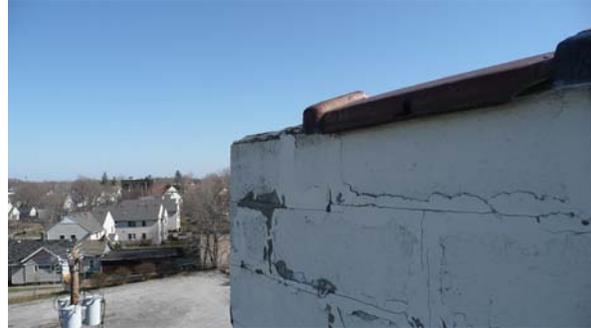
- m. At the North West corner of the building a cap stone to the parapet wall is missing and has been filled in with tar. The Tar has failed and has sunk into the cores of the masonry wall allowing for water infiltration. This is evident as spalling of the exterior surface is occurring due to the freeze thaw process. This area will have to be repointed once the deficiency is corrected.

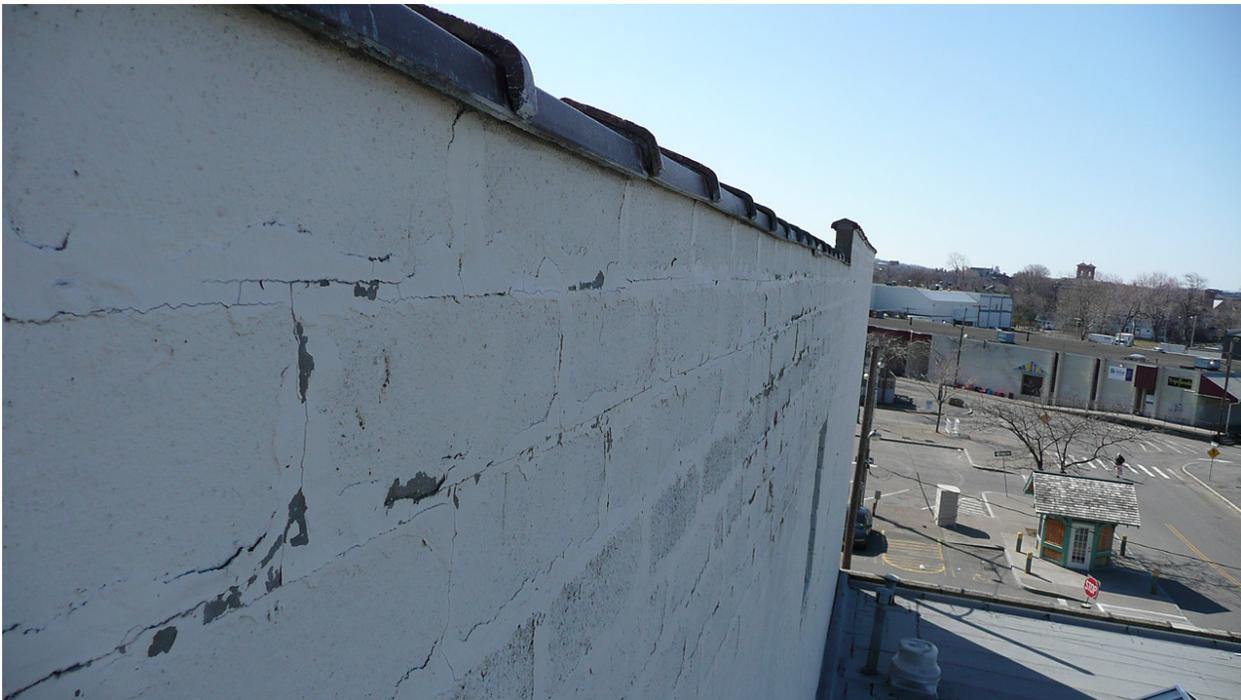
- n. At the North wall a failed flashing is allowing water infiltration. This is evident as an area approximately 12' long by 7 courses tall is spalling from the freeze thaw process. This area will need to be repointed once the deficiency is corrected.

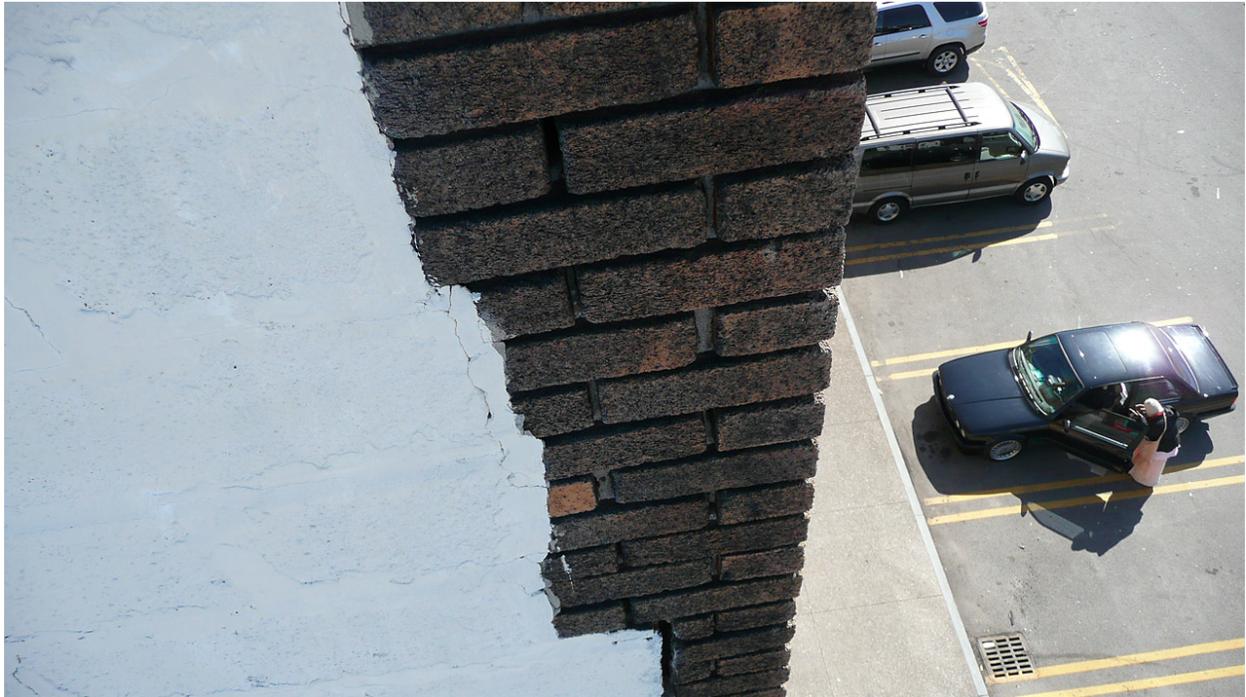
- o. The brick façade at the SW & SE corners needs repointing.

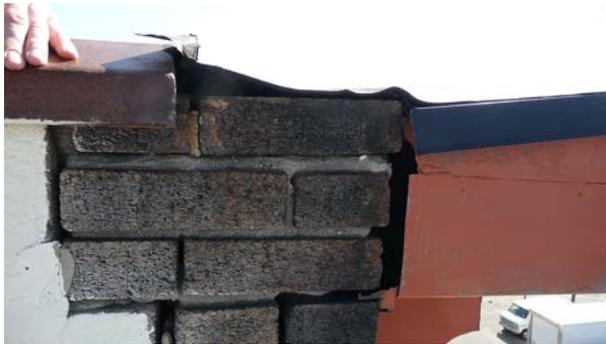
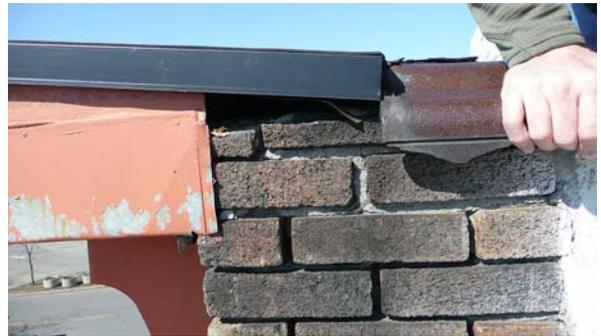
- p. The tin fascia assembly is open at the SW & SE corners as it attaches to the building.

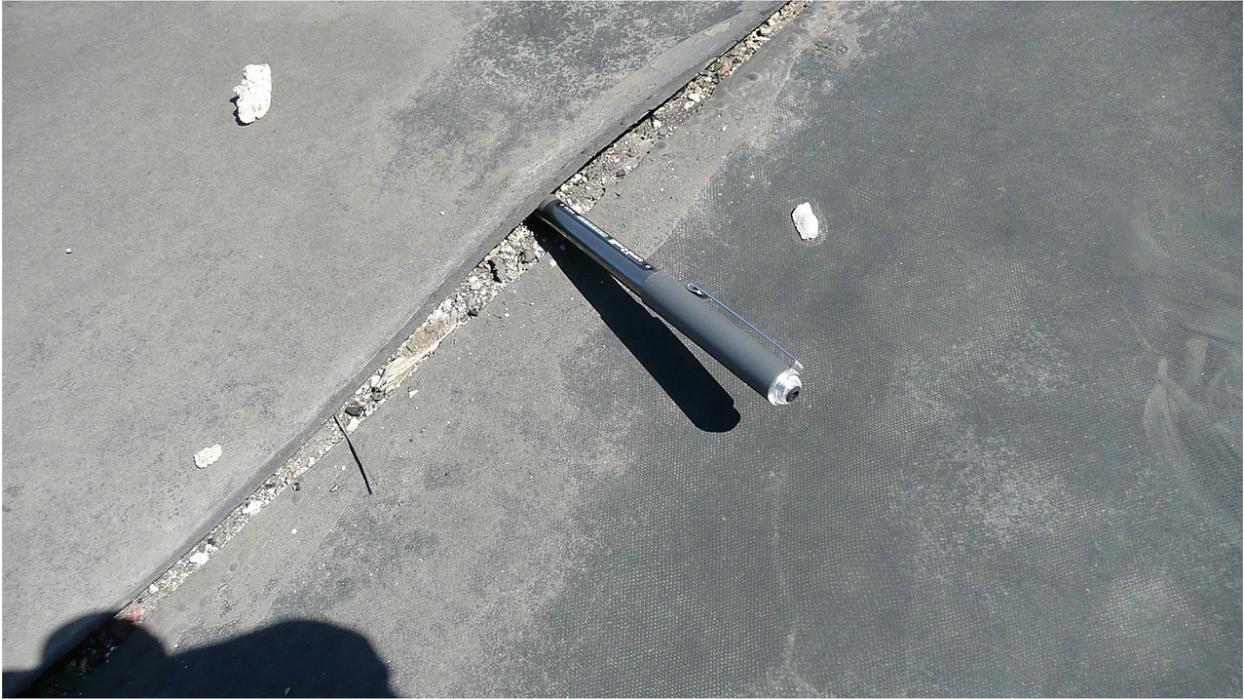
- a. The lower roof is a rubber roof.
- b. Several seams at the lower roof are showing signs of wear and will eventually need to be re-glued.

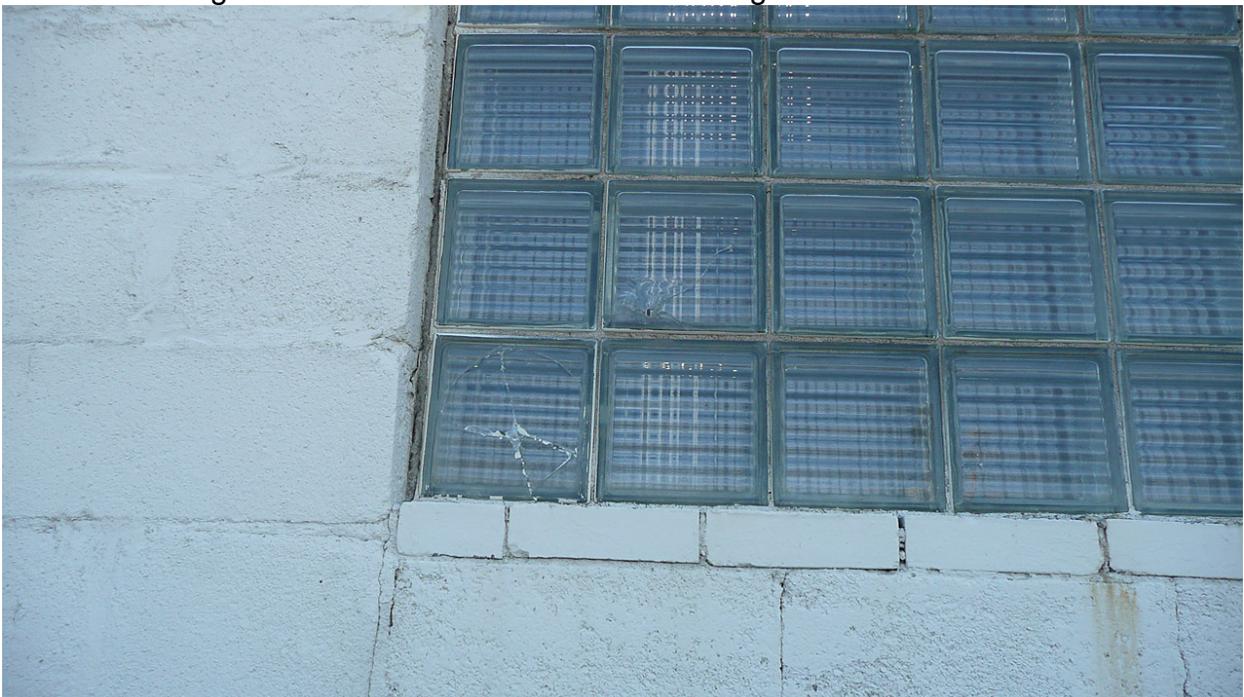
- c. Several glass blocks are broken from rock damage.

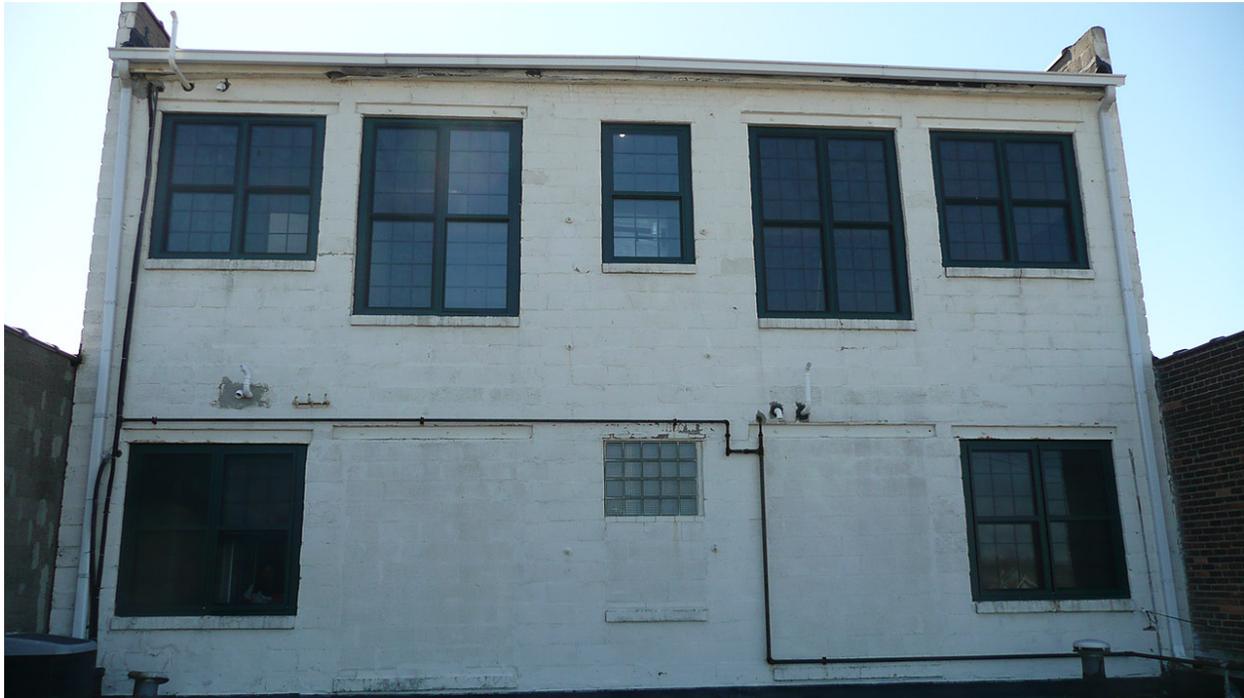
- d. Two double hung windows @ the third floor level have broken glass from rock damage. This may be prevented by adding security screens as on the lower windows.

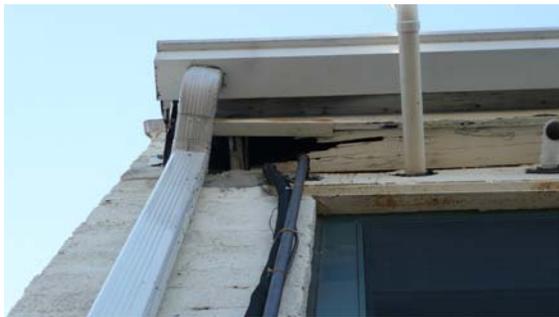
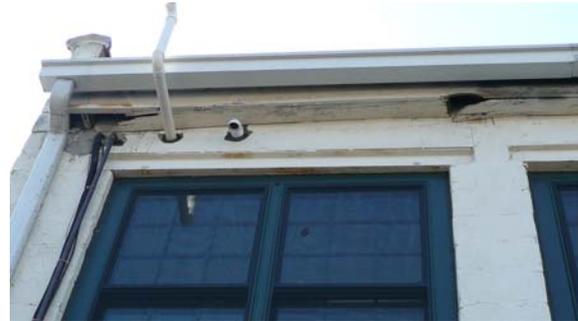
- e. The wood at the fascia has several large holes in it. The wood fascia is in need of general repair and paint.

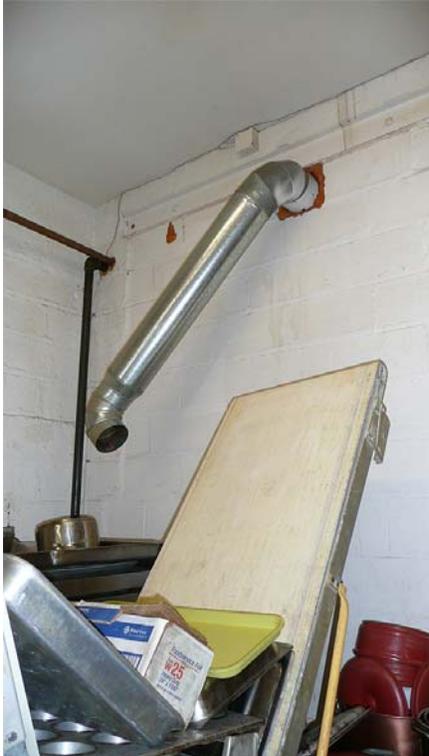
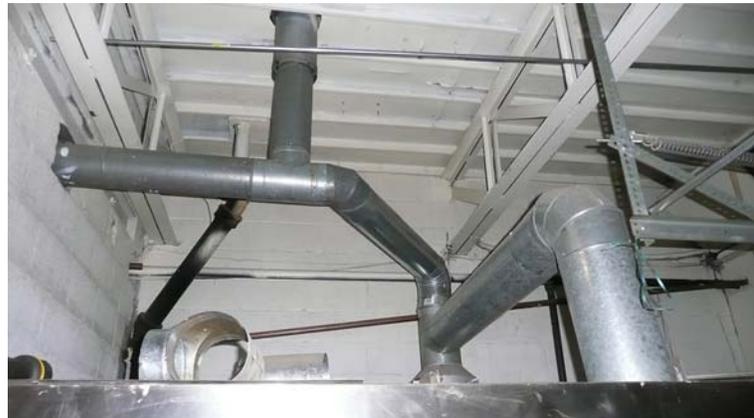
- e. At the second floor the SE window has a broken slide on the bottom E. side of window.
- f. At the second floor E. unit two outlets are not working above the countertop.
- g. At the first floor W. unit an exhaust pipe that is not being used is unconnected and needs to be capped to avoid exhaust gasses from entering the building. Note that down stream of this exhaust this same feed leads into the exhaust of a large commercial oven which is being used.

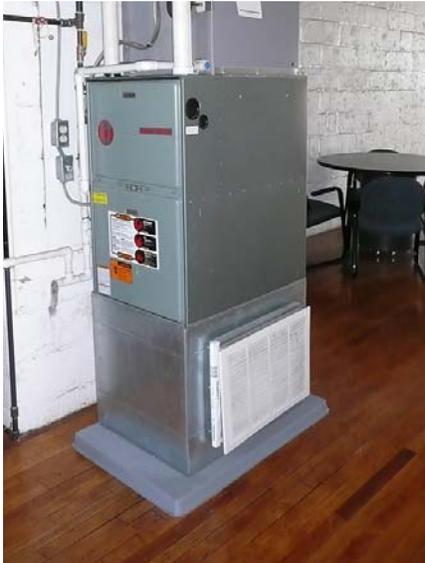
- b. Much of the electric looks to have been replaced recently.
- c. No heat was available to the third floor W. side.
- d. A Rheem Classic 90 plus furnace serviced the third floor E. side. This unit appears to have a DX coil installed to provide cooling but the realtor indicated that no cooling was currently available. This furnace operated by a programmable thermostat. It is fairly new, maintained and was in good working order at the time of the inspection.
