# David M Kaye Home Inspections

## Home Inspection Report

**100 Sample Street**

Inspected on Tue, Nov 21 2017 at 10:00 AM

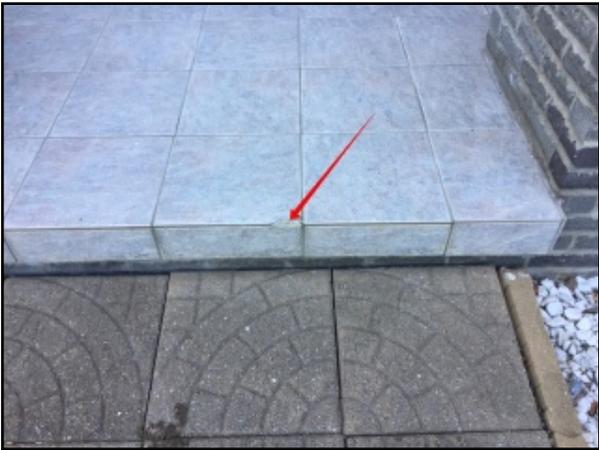
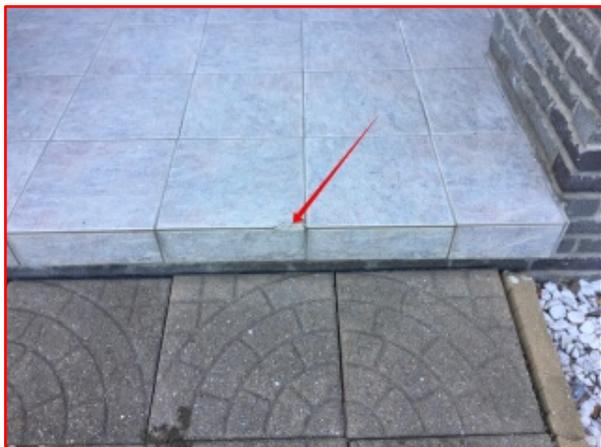
Figure 2-1

Comment 2:  
Chipped tile at front entrance.

1) Chipped tile at front entrance.

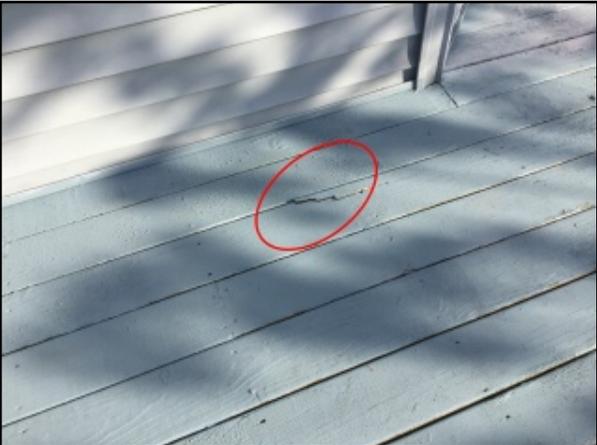
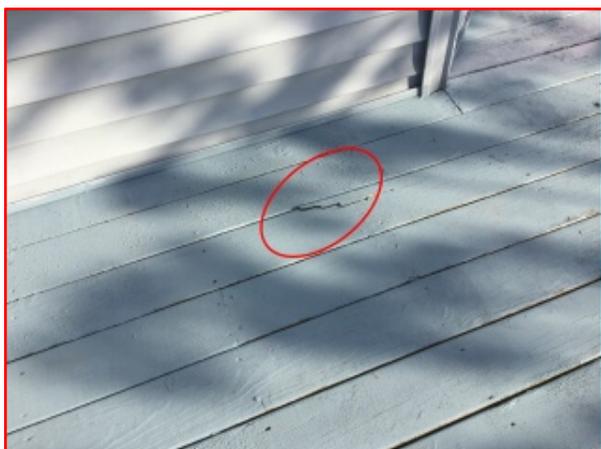
Figure 3-1

Comment 3:  
Deck board is splintered.

2) Deck board is splintered.

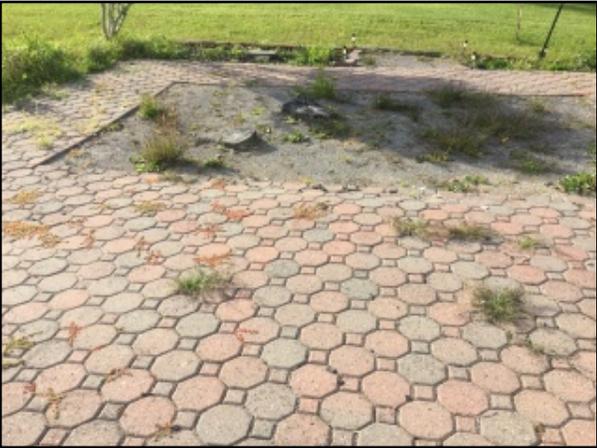
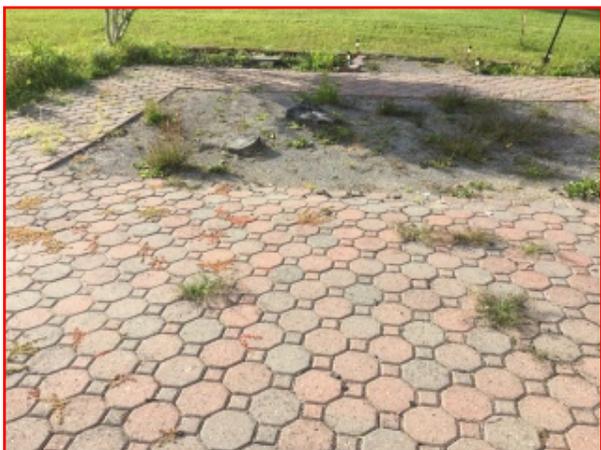
Figure 4-1

Comment 4:  
Pavers have settled at edges.

3) Pavers have settled at edges.

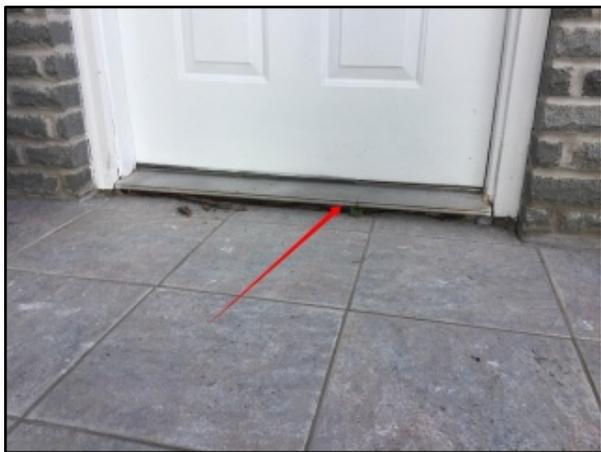
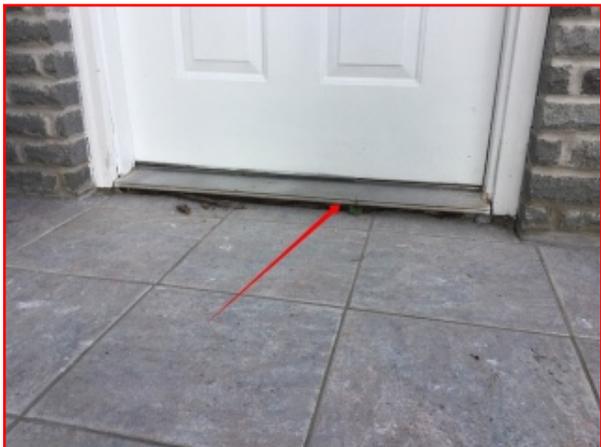
Figure 5-1

Sub flooring under door sill is deteriorated. If replaced use pressure treated lumber at this location.

4) Sub flooring under door sill is deteriorated. If replaced use pressure treated lumber at this location.

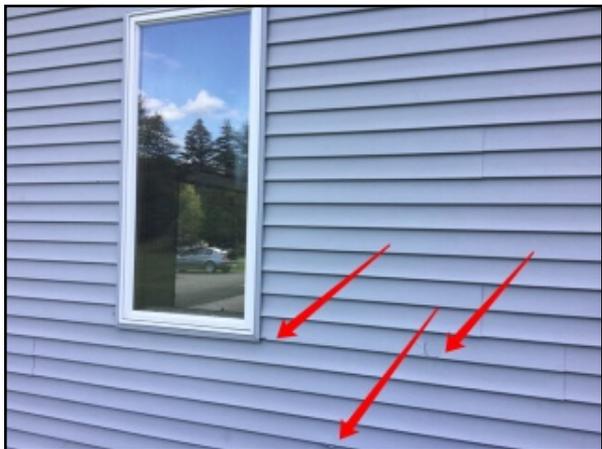
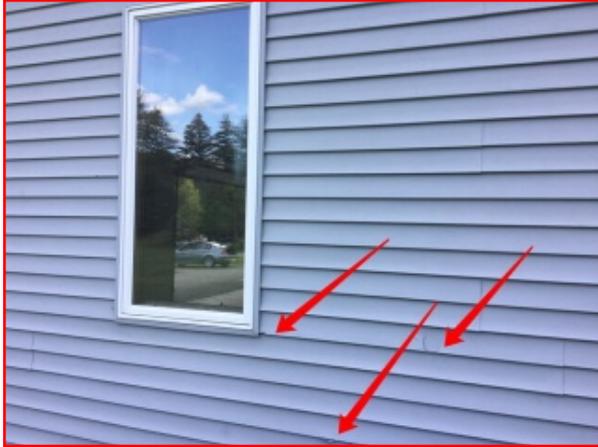
Figure 6-1

Comment 6:  
Siding damaged at several locations.

5) Siding damaged at several locations.

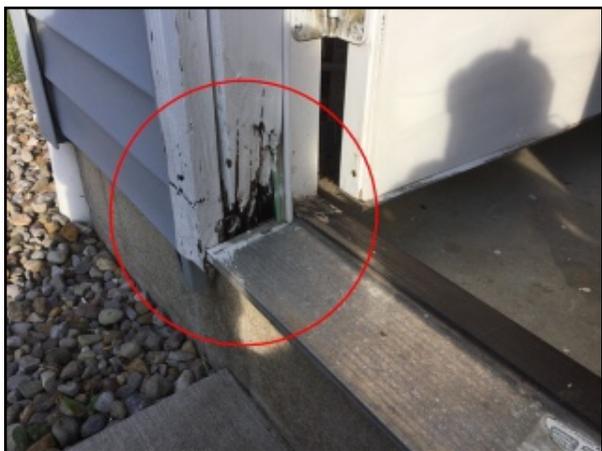
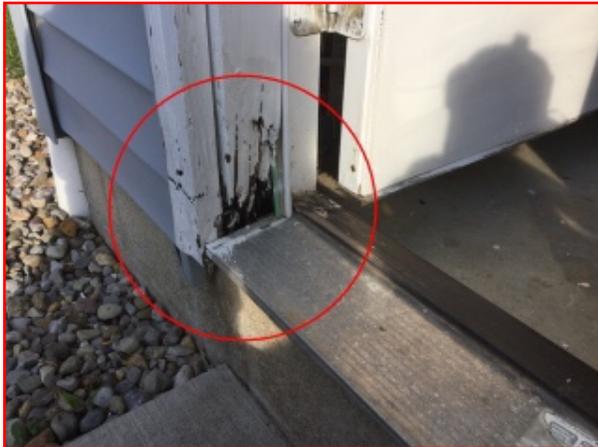
Figure 7-1

Comment 7:  
Door jamb is rotted at rear garage door.

6) Door jamb is rotted at rear garage door.

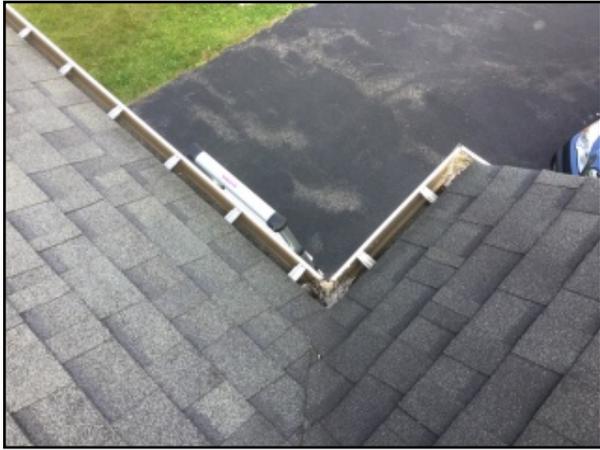
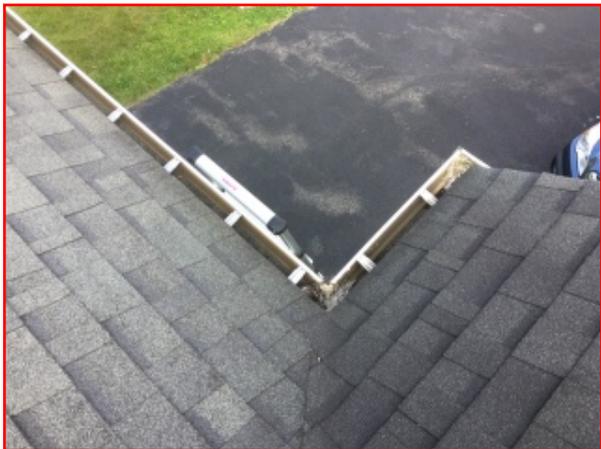
Figure 8-1

**Comment 8:**  
In general the gutters are clean of debris. Several tennis balls in gutters.

7) In general the gutters are clean of debris. Several tennis balls in gutters.

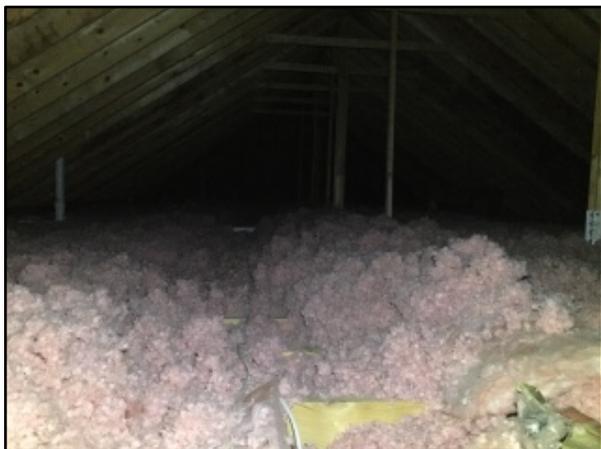
Figure 9-1

Comment 9:  
Some blown insulation has been moved around due to work in the attic.

Suggest insulation above access panel in the closet.

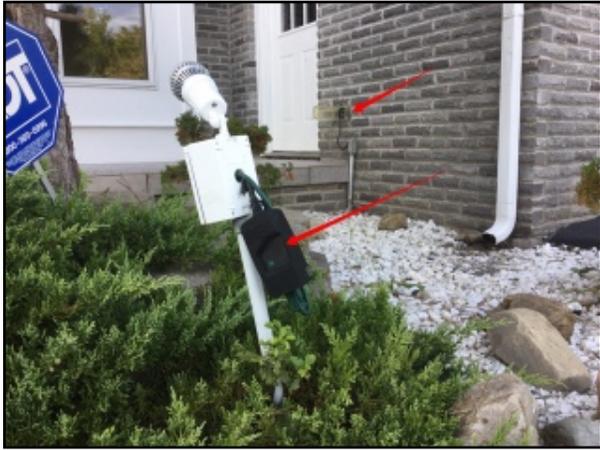
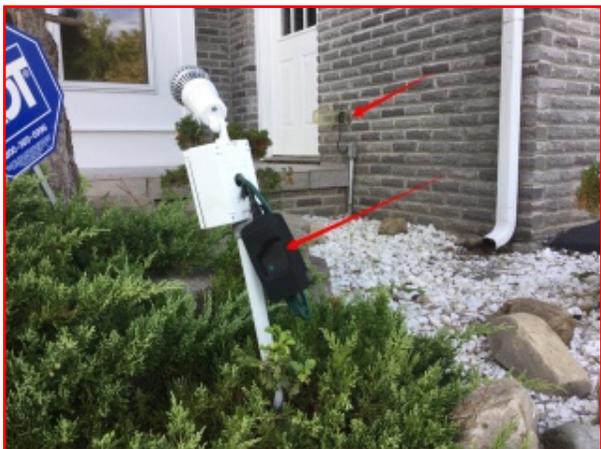
Figure 10-1

Comment 10:  
Lighting under tree is plugged into outlet by garage door.

8) Lighting under tree is plugged into outlet by garage door.

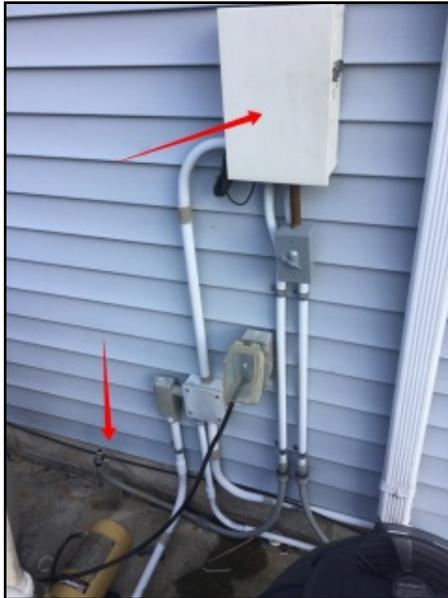
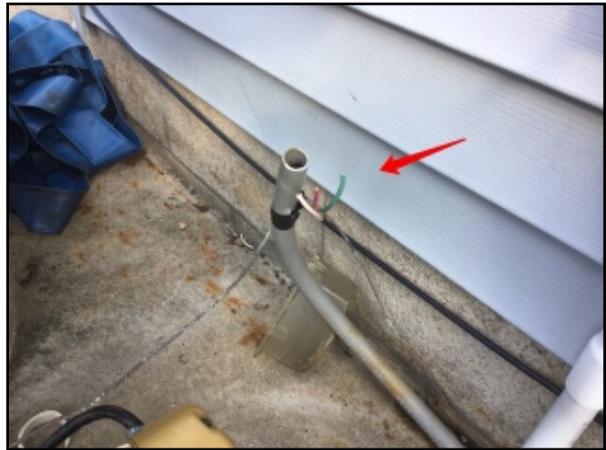
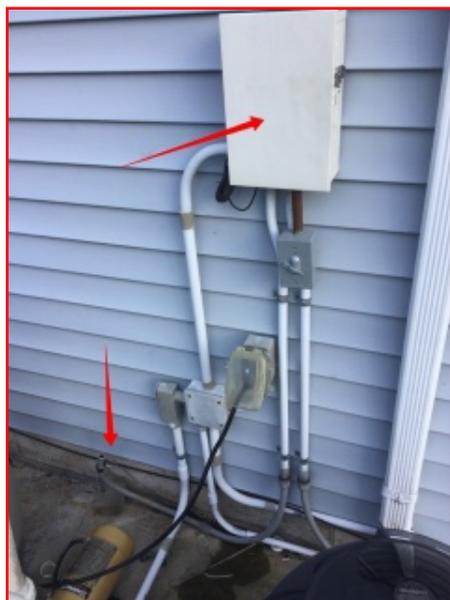
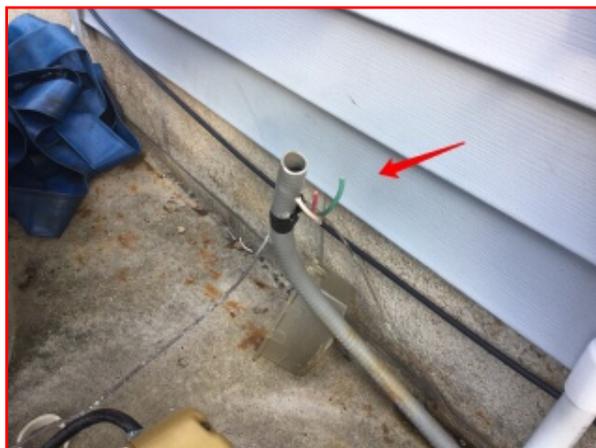
Figure 11-1

Comment 11:  
Exposed electrical wiring coming out of control box by pool pump.

9) Exposed electrical wiring coming out of control box by pool pump.

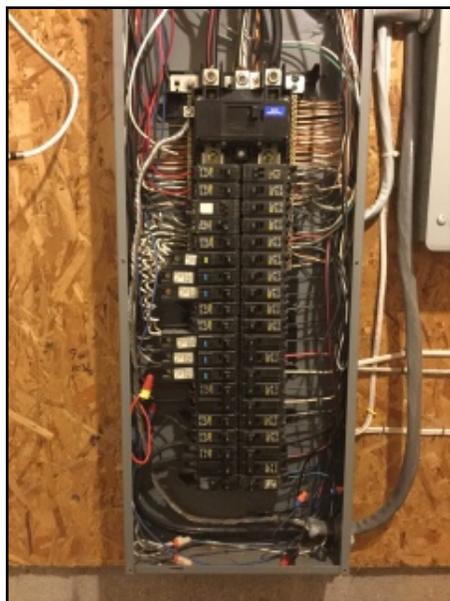
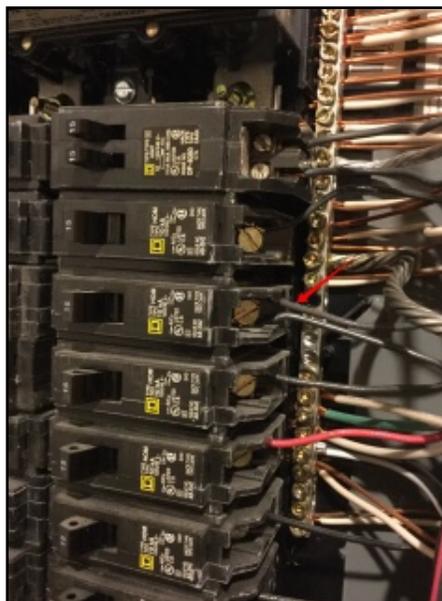
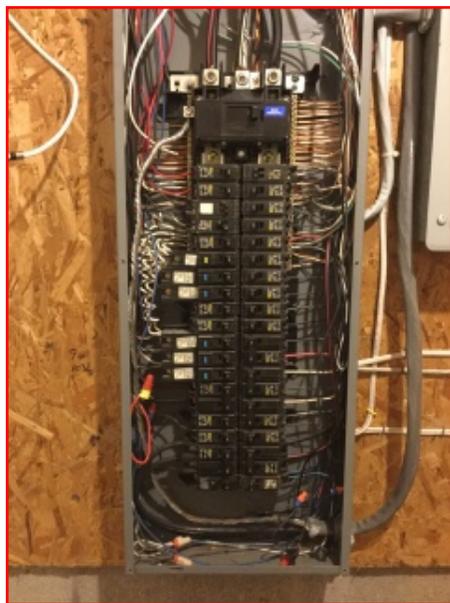
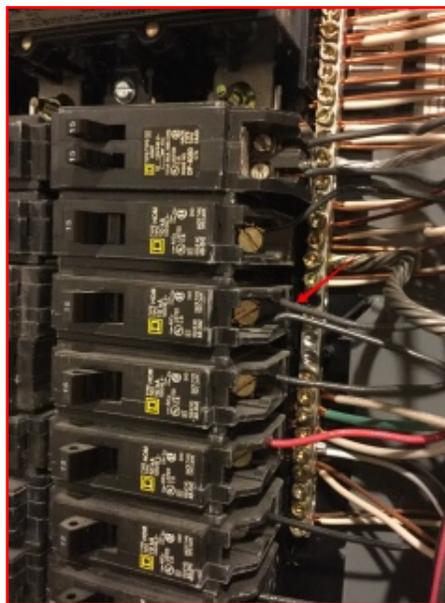
Figure 12-1

Breaker 6 is double tapped. Each circuit needs its own breaker.

10) Breaker 6 is double tapped. Each circuit needs its own breaker.

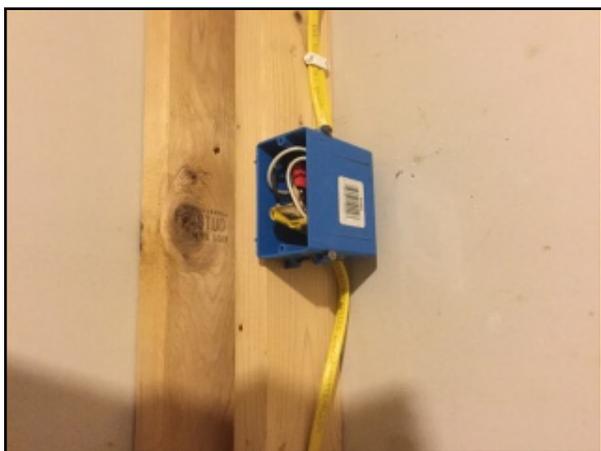
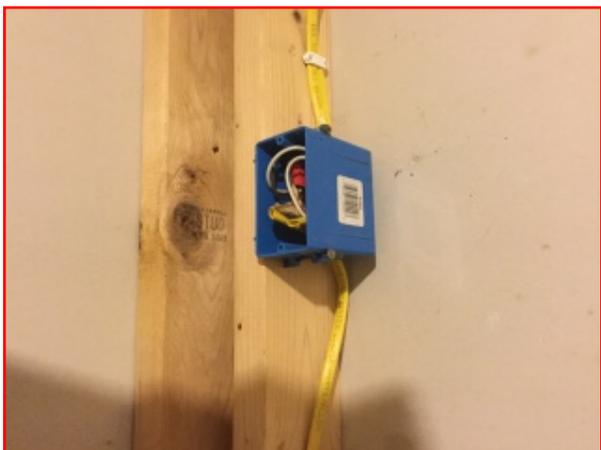
Figure 13-1

Open junction box in electrical closet that needs a cover plate.

11) Open junction box in electrical closet that needs a cover plate.

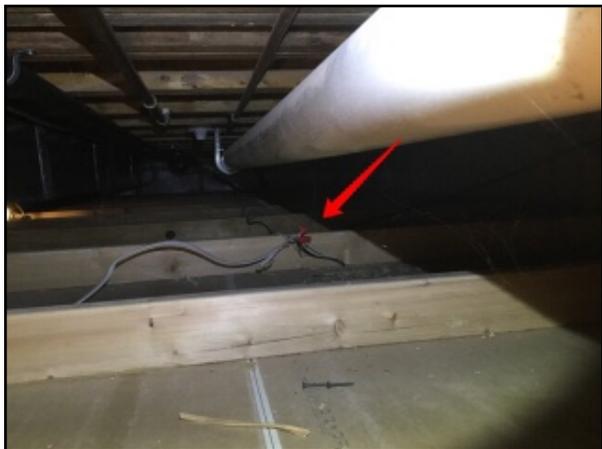
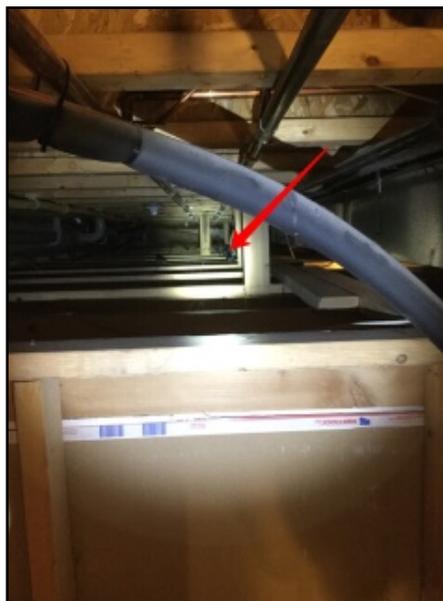
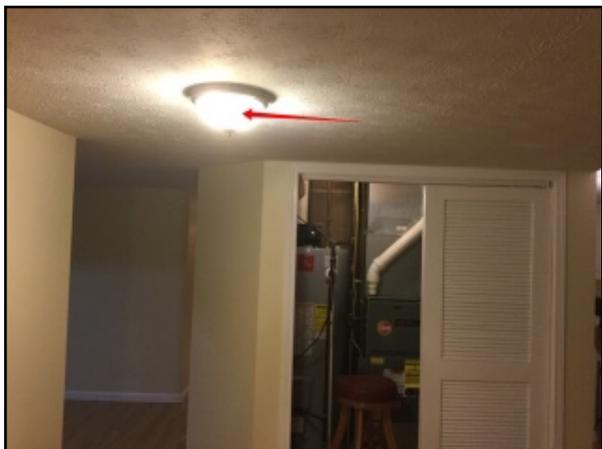
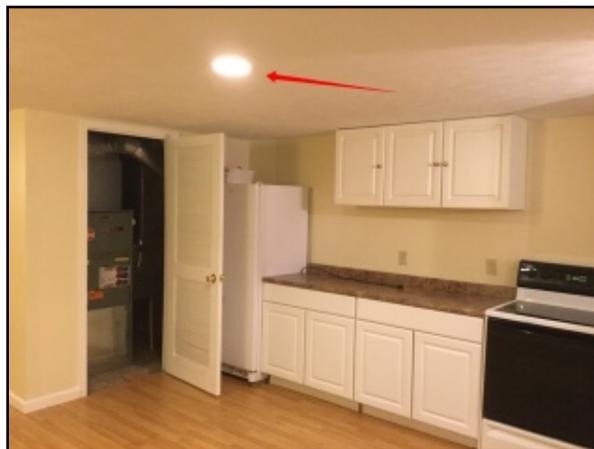
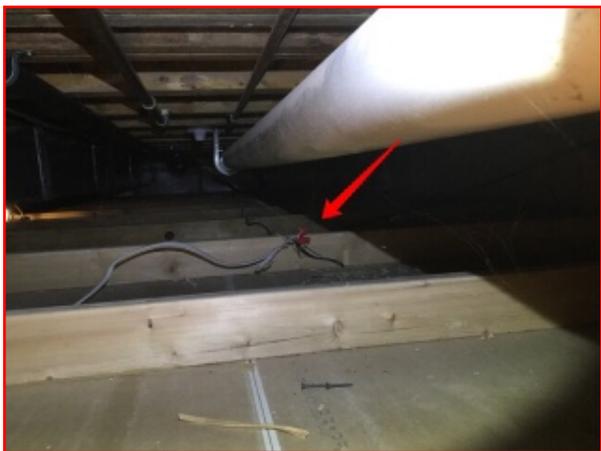
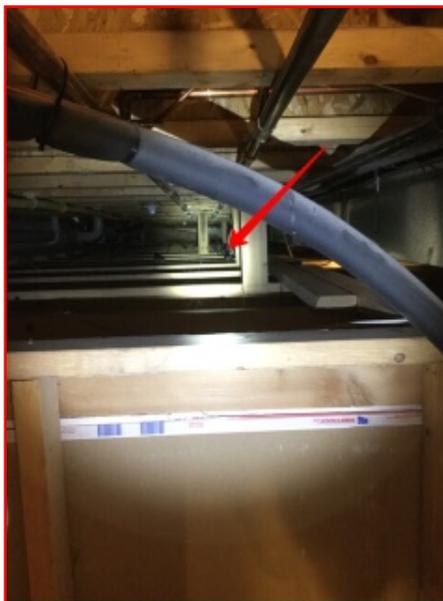
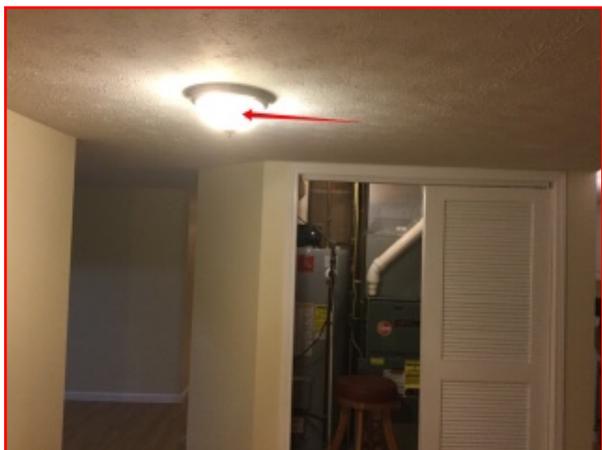
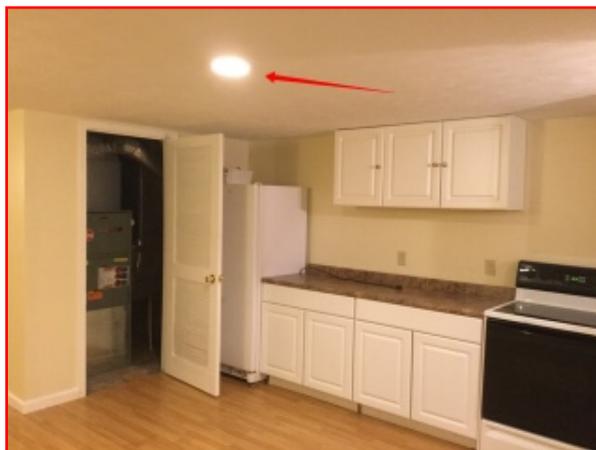
Figure 14-1

**Comment 14:**  
Wiring not concealed in junction boxes at several lights in basement.

12) Wiring not concealed in junction boxes at several lights in basement.

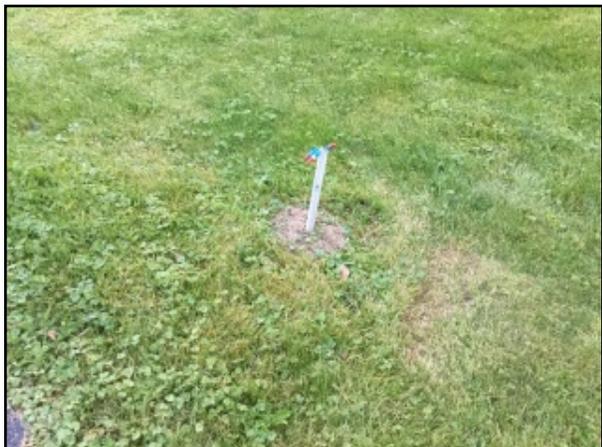
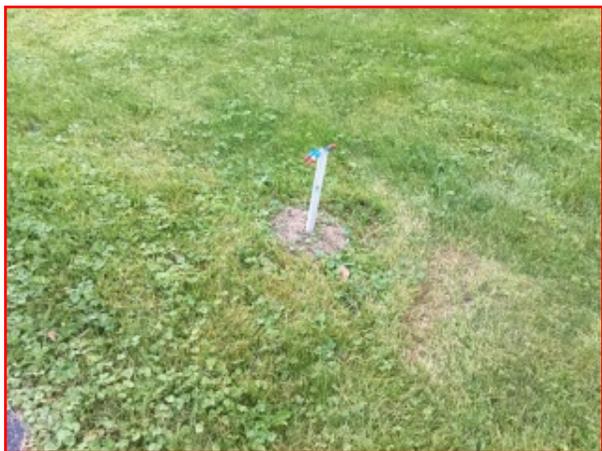
Figure 15-1

Comment 15:  
Open electrical conduit at front yard.

13) Open electrical conduit at front yard.

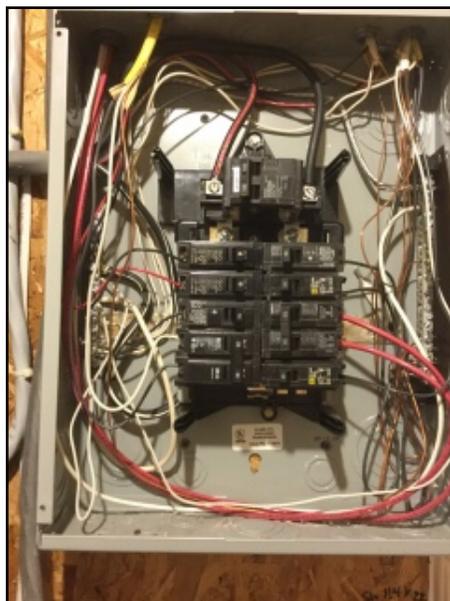
Figure 16-1

Comment 16:  
2 spare breakers at sub panel.

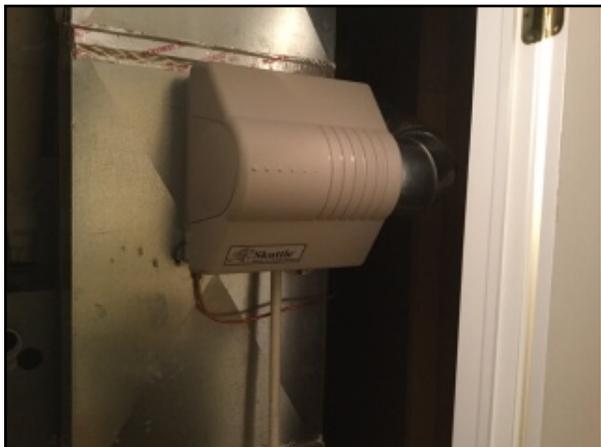
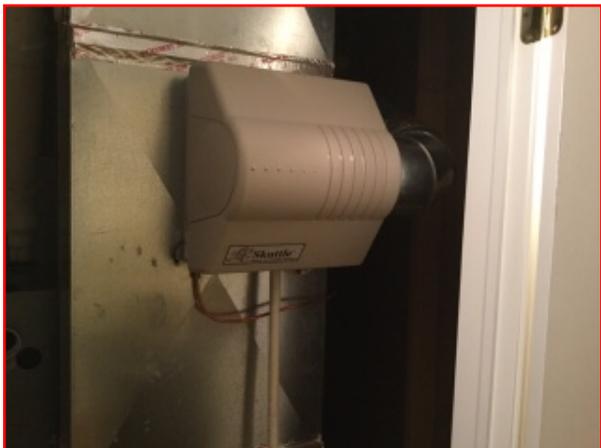
Figure 19-1

Unable to get humidifier to run at time of inspection.

15) Unable to get humidifier to run at time of inspection.

Furnaces over 10 years old should be checked, cleaned and serviced yearly by a licensed contractor.

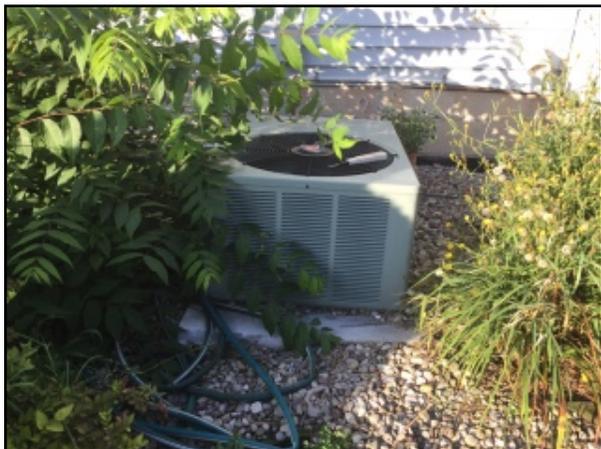
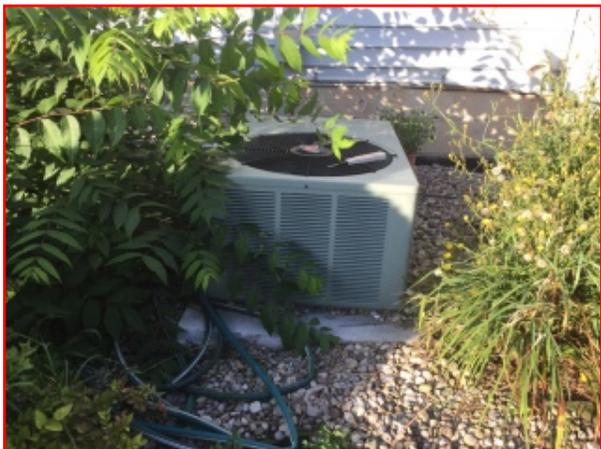
Figure 22-1

17) Trim back vegetation from condenser.

Comment 22:  
Trim back vegetation from condenser.

Air conditioners over 10 years old and heat pumps over 5 years old should be checked, cleaned and serviced yearly by a licensed contractor.

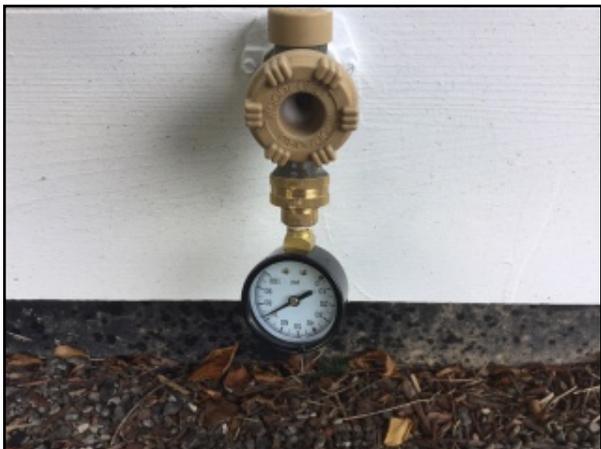
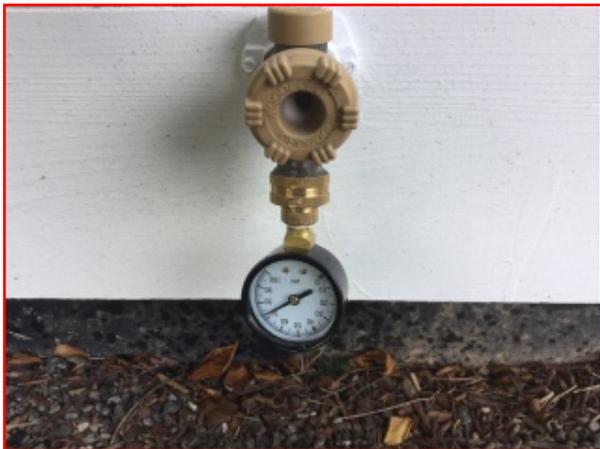
Figure 23-1

Comment 23:  
Water pressure the time of inspection is 70 psi.

18) Water pressure the time of inspection is 70 psi.

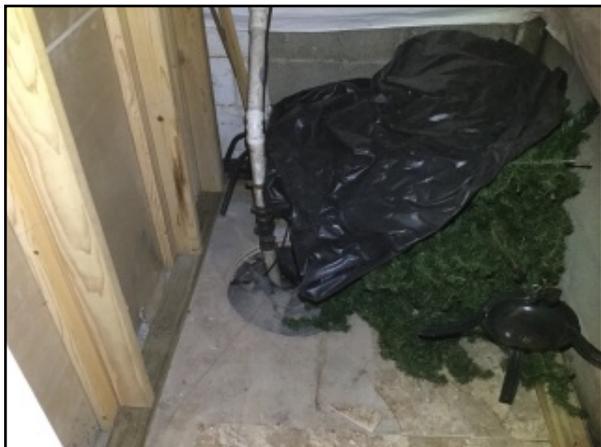
Figure 25-1

Comment 25:  
Second sump pump working at time of inspection.

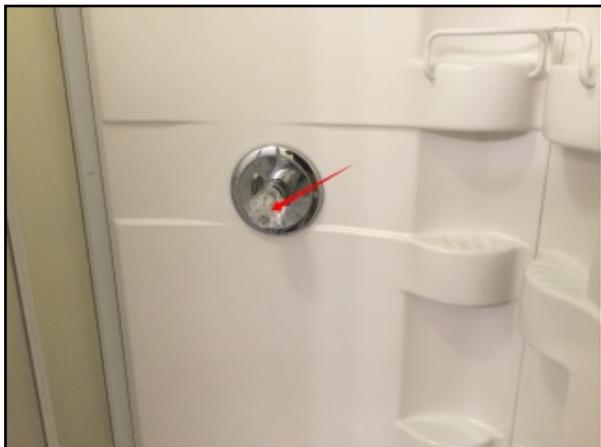
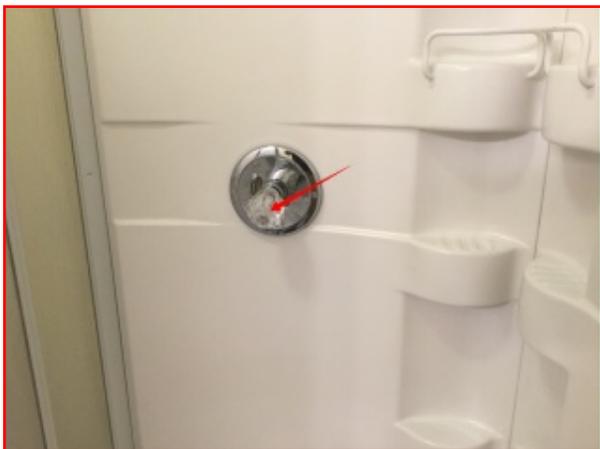
Figure 27-1

Comment 27:  
Shower handle is not attached.

19) Shower handle is not attached.

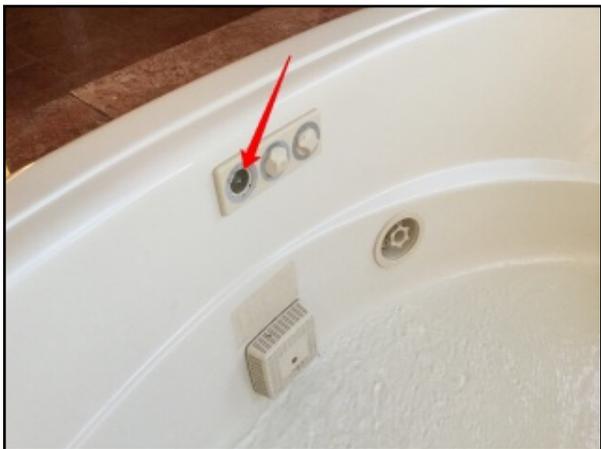
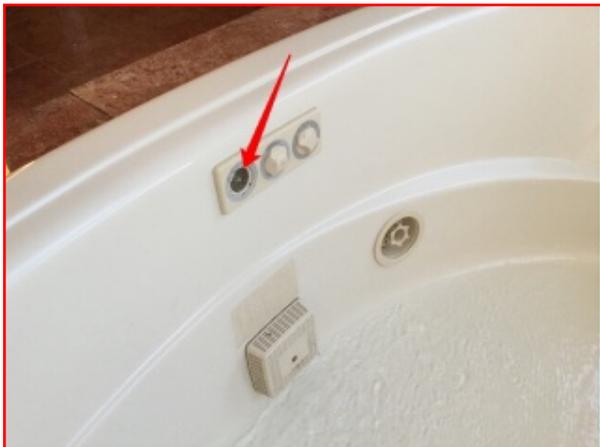
Figure 30-1

Comment 30:  
Dial missing at tub.

20) Dial missing at tub.

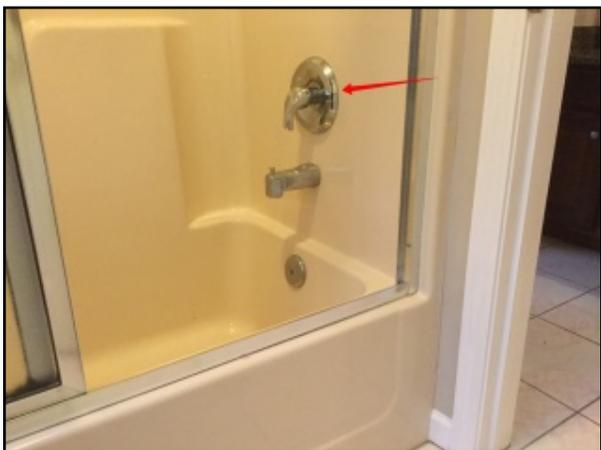
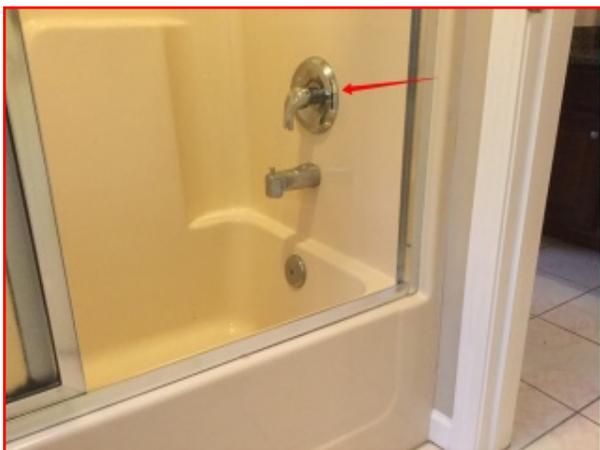
Figure 33-1

Comment 33:  
Note that while I was filling the Jacuzzi tub there was no hot water flow to the shower in this bathroom.

21) Note that while I was filling the Jacuzzi tub there was no hot water flow to the shower in this bathroom.

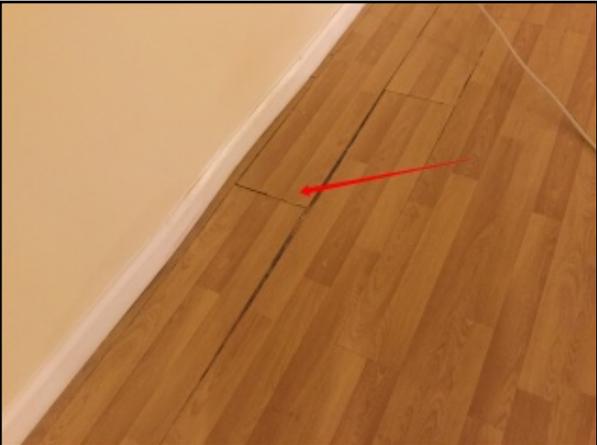
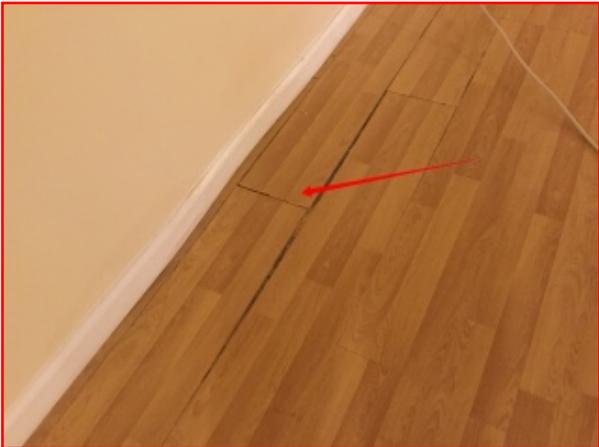
Figure 35-1

Comment 35:  
Flooring has slid apart at basement floor.

22) Flooring has slid apart at basement floor.

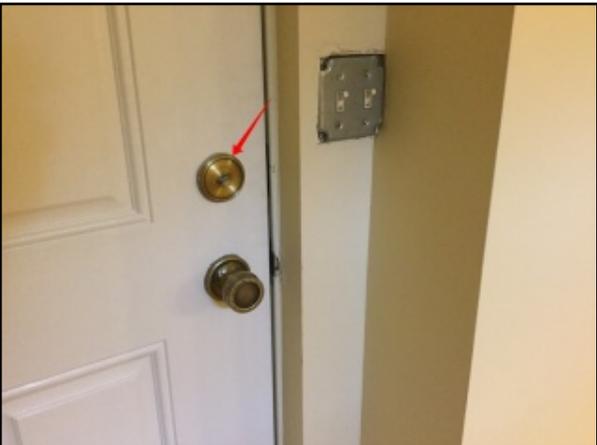
Figure 36-1

Comment 36:  
Thumb turn to dead bolt missing at basement door to garage.

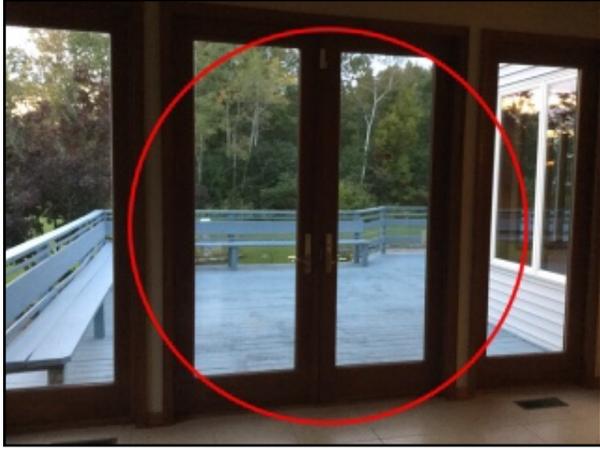
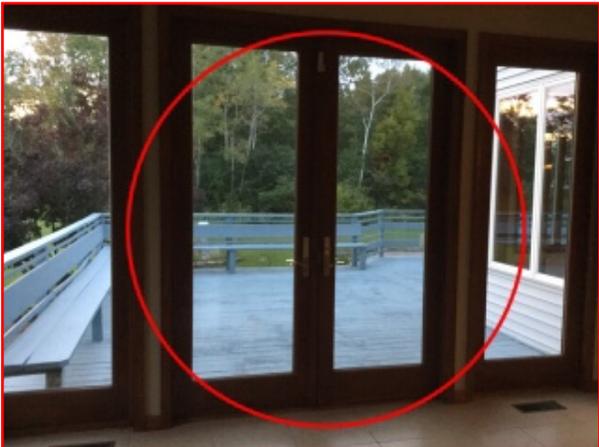
Figure 37-1

Comment 37:  
Unable to get doors to open.

23) Unable to get doors to open.
